INSPECTION REPORT

CATERPILLAR 140M2

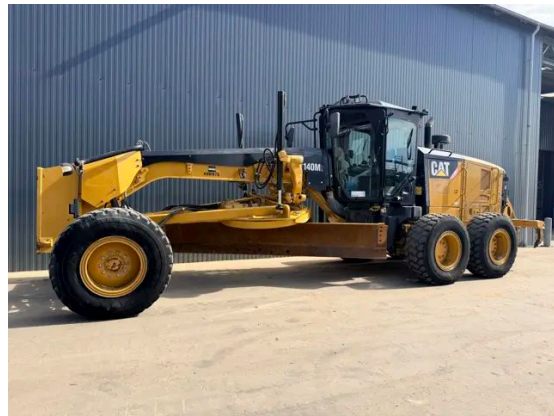
The Caterpillar 140M2 is a robust and reliable motor grader powered by the Caterpillar C9.3 engine, delivering 182 kW. It is equipped with essential features such as air conditioning, EPA certification, and a low profile EROPS cabin for enhanced operator comfort. The machine includes a push block, ripper, and a 6x4 drive system, ensuring efficient performance on any site. It also offers a blade width of 4.26 meters, auto-shift capabilities, and differential unlock. This machine has been certified by Caterpillar for its 9773 operational hours and is in excellent, clean condition. Additional extensions can be quoted upon request.
