INSPECTION REPORT

CATERPILLAR 140M2

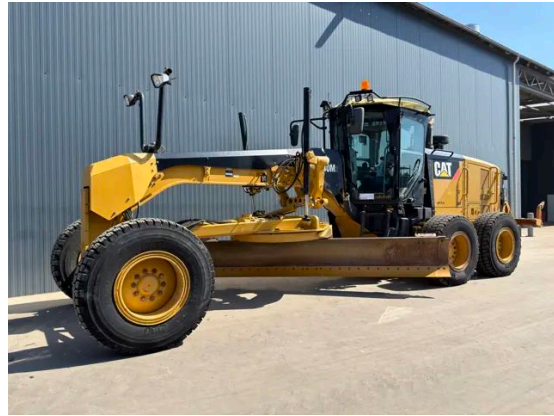
The Caterpillar 140M2 is a robust motor grader equipped with a Caterpillar C9.3 engine. This machine is ready for heavy-duty tasks with a 6x4 drive, ripper, and a hydraulic tip control that allows precision in grading. The 4.27m center blade and backup camera enhance operational efficiency and safety. Designed with comfort in mind, it includes an AM/FM radio and a beacon for visibility. Certified hours by Caterpillar and excellent condition confirm its reliability.
