CATERPILLAR 323D LN

Year	2008
Hours	11470
Weight	24.050 kg
Serial number	CAT0323DKJLG00389
Reference	209545

INSPECTION REPORT

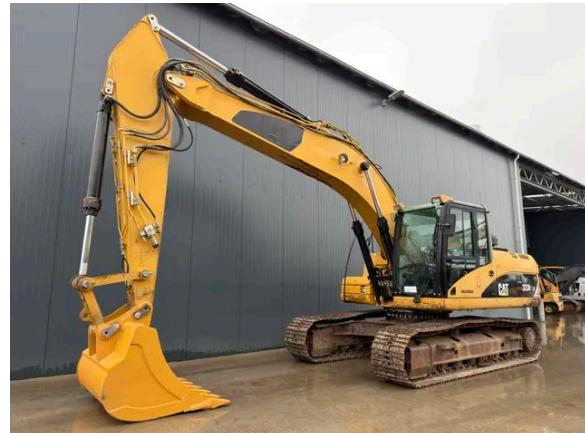
Caterpillar 323D LN, Engine brand and model Caterpillar C6.4, 110 kW, CE, Air conditioning, Width of the pads 600mm, Mono boom, Length of the mono boom 5.70m, Length of the stick 2.90m, New digging bucket with teeth, Width of the bucket 1.40m, Piped for hammer, shear and clamp, Burst valve on lift cylinder, Hours certified by Caterpillar, In good and clean condition.
