## CATERPILLAR M318F

<b>Year</b>	2015
<b>Hours</b>	13836
<b>Weight</b>	17600 kg
<b>Serial number</b>	CATM318FAF8B00299
<b>Reference</b>	211558

# INSPECTION REPORT

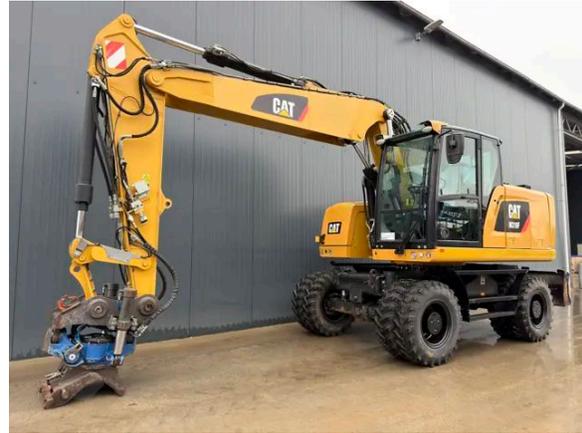
Caterpillar M318F, Engine brand Caterpillar, C7.1, 129 kW, EPA, CE, Central lubrication, Backup camera, Backup alarm, Immobilizer, Tyre size 10.00-20 Bridgestone NEW!, V/A boom, Length of the stick 2.40m, Hydraulic quick release, Piped for hammer, Burst valve on lift, V/A and stick cylinder, AM/FM radio, Hours certified by Caterpillar, In very good and very clean condition.

Engine brand	Caterpillar
Engine Model	C7.1
Engine power in kW	129 kW
EPA	✓
CE	✓
Tyre size	10.00-20 Bridgestone NEW!
Boom	V/A boom
Piped	Piped for hammer
Burst valve	Burst valve on lift, V/A and stick cylinder
Hours	Hours certified by Caterpillar
Overall condition	In very good and very clean condition.
