INSPECTION REPORT

CATERPILLAR 990H

Year	2007
Hours	0
Weight	82.297 kg
Serial number	CAT0990HCBWX00354
Reference	211038

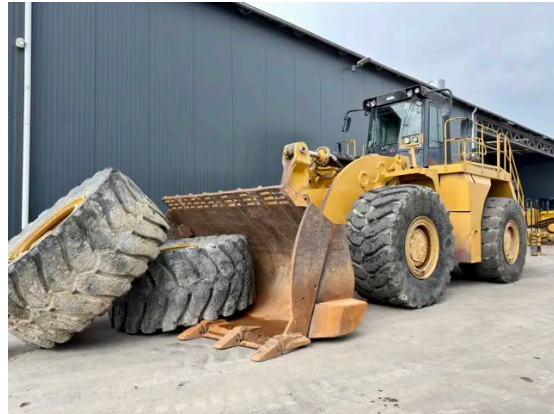
The Caterpillar 990H is a robust wheel loader equipped with a powerful Caterpillar C27 engine, delivering 468 kW. It includes features such as a CE certified EROPS cabin, a GP bucket with teeth, joystick control, ride control, backup camera, and alarm. With 45/65R39 tires and a central lubrication system (untested), this machine boasts 22,278 certified hours by Caterpillar. It's in very good and clean condition, weighs 82.297 kg, and measures 12.90 x 5.04 x 5.13 meters.
