## INSPECTION REPORT

### CATERPILLAR 320E L

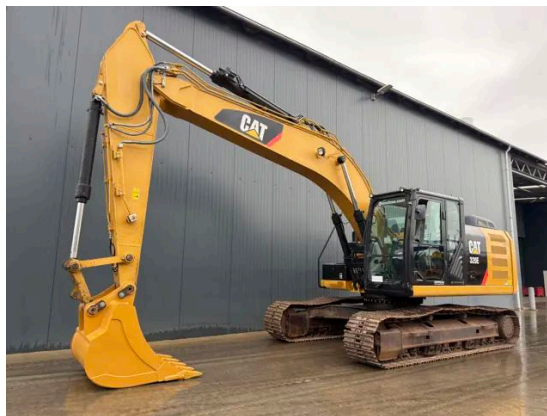
The Caterpillar 320E L is a robust tracked excavator, model year 2013, originating from Japan. It operates with a powerful Caterpillar C6.6 engine delivering 113 kW. The machine is well-equipped with an EPA and CE compliance, features air conditioning, and a backup camera to ensure safe operation. It includes a mono boom with a length of 5.70m and a stick of 2.90m, supported by a new 1.20m wide digging bucket with teeth. The excavator is piped for a hammer and comes with a burst valve on the lift and stick cylinder, AM/FM radio, and has been certified for hours by Caterpillar. Its overall condition is very good and clean.
