## VOLVO G930 - CE

Year	2010
Hours	8465
Weight	17.650 kg
Serial number	VCE0G930A00041117
Reference	206600

# INSPECTION REPORT

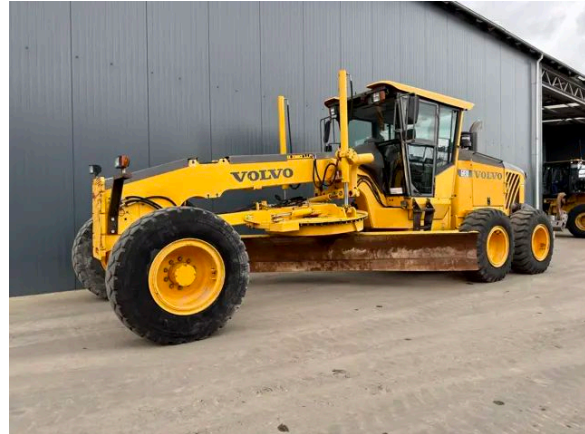
Volvo G930, Engine and model Volvo D7E GCE3, 150 kW, EPA, CE, 17.5-25, Ripper, 6x4, Hydraulic tip control, Width of the center blade 4.27m, Differential unlock, Beacon, Extensions available, ask for quotation, In good and very clean condition.
