## INSPECTION REPORT

### CATERPILLAR 140M3 AWD

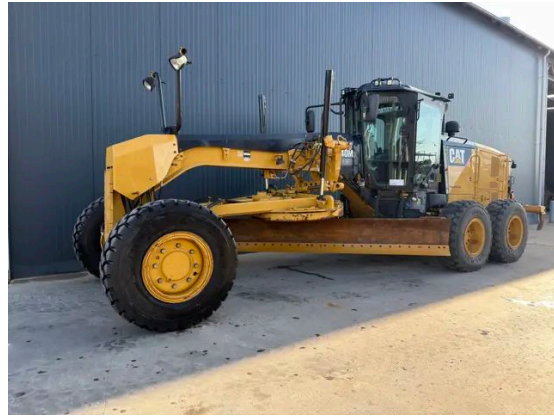
The Caterpillar 140M3 AWD is an advanced motor grader built for precision and durability. Powered by a robust Caterpillar 9.3 engine, it ensures high performance across a range of tasks. The machine is equipped with advanced features such as auto shift, hydraulic tip control, and a center blade with a width of 4.27 meters. Designed for operator convenience, it has a backup camera, differential unlock, and is GPS ready. With EPA compliance, a ripper, and a 6x6 drive configuration, this grader is prepared to tackle tough terrains. Additionally, it boasts a clean and well-maintained record, making it an excellent choice for efficient operations.
