CATERPILLAR 352F XE

Year	2017
Hours	11021
Weight	52.160 kg
Serial number	CAT0352FVMDR10014
Reference	209244

INSPECTION REPORT

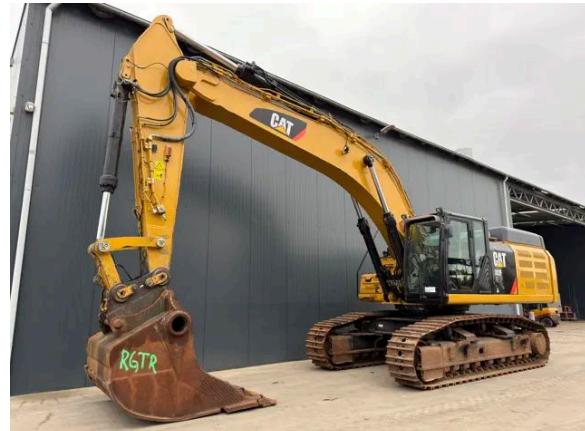
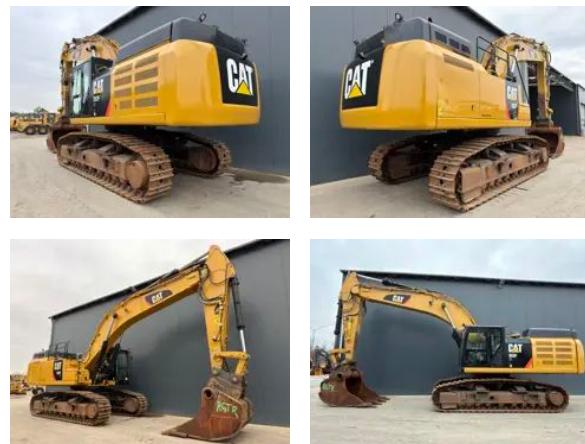
Caterpillar 352FXE, Engine brand and model Caterpillar C13, 317 kW, EPA, CE, Air conditioning, Central lubrication, Backup camera, Backup alarm, Weight load indicator, Width of the pads 600mm, Mono boom, Length of the mono boom 6.90m, Length of the stick 3.35m, Hydraulic quick release, Digging bucket with teeth, Width of the bucket 1.99m, Piped for hammer & shear, Burst valve on lift and stick cylinder, Hours certified by Caterpillar, In very good and very clean condition.
