CATERPILLAR 330D L

Year	2007
Hours	8909
Weight	37.500 kg
Serial number	CAT0330DCRAS00916
Reference	209663

INSPECTION REPORT

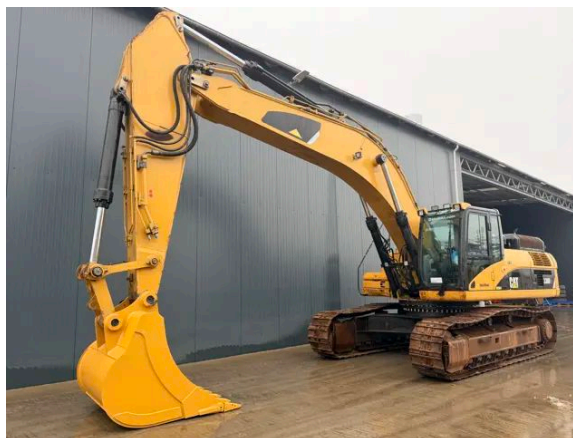
Caterpillar 330L E, Engine brand and model Caterpillar C9DI, 200kW, CE, Air conditioning, Central lubrication, Width of the pads 600mm, Mono boom, Length of the mono boom 6.50m, Length of the stick 3.20m, New digging bucket with teeth, Width of the bucket 1.40m, Piped for hammer, shear and clamp, Burst valve on lift cylinder, Hours certified by Caterpillar, In good and clean condition.
