## INSPECTION REPORT

### CATERPILLAR 950H

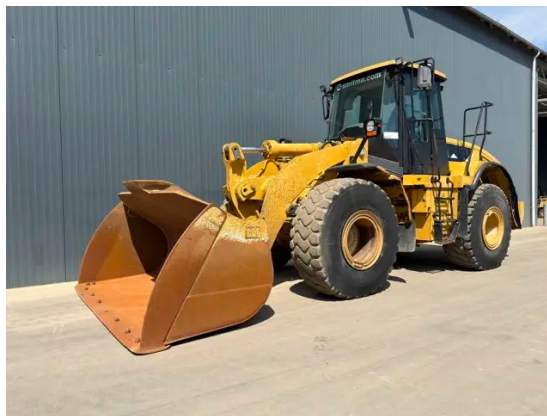
The Caterpillar 950H is a robust and efficient wheel loader, powered by a Caterpillar C7 engine that delivers 146 kW, ensuring high performance and reliability. This 2008 model features a well-maintained, spacious EROPS cabin for operator comfort and safety. It's equipped with a GP bucket with a bolt-on edge, measuring 3.00m in width, for versatile material handling. The machine is fitted with 23.5R25 tires and boasts a complete steering wheel, ride control, and autoshift for ease of operation. Certified by Caterpillar, it records 11,116 operating hours and is documented to be in good and clean condition, ready for immediate work.
