## INSPECTION REPORT

### CATERPILLAR 336D L

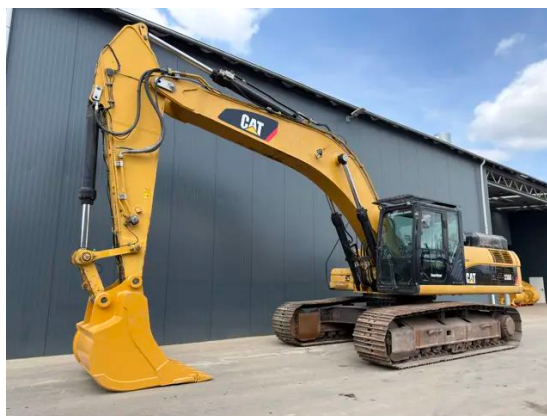
The Caterpillar 336D L is a highly efficient excavator fitted with a powerful Caterpillar C9 engine, delivering 213 kW. Designed with operational efficiency in mind, it features CE certification, air conditioning for operator comfort, central lubrication for reduced maintenance time, and a backup camera and alarm for enhanced safety. This model comes fitted with a mono boom with a length of 6.50 meters and a stick of 3.20 meters, supporting a new digging bucket with teeth. The excavator is piped for hammer and shear, featuring a burst valve on both the lift and stick cylinder. Manufactured in 2011, with certified hours by Caterpillar, it remains in excellent and very clean condition.
