INSPECTION REPORT

DYNAPAC CC1300

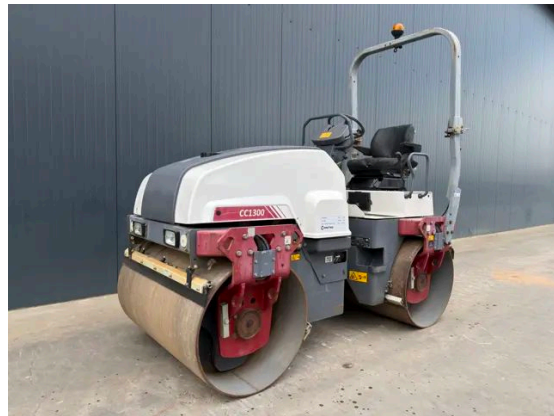
The DYNAPAC CC1300 is a powerful 2018 model vibrating roller, equipped with a reliable Kubota V2203 engine providing 33.3kW of power. With a drum width of 1.30 meters, this machine ensures efficient compaction. Features include a water sprinkler system, drum drive, vibrating drums, backup alarm, and a beacon. The machine is in excellent, clean condition, with genuine hours of 1143 and CE certification. Manufactured in Sweden, it weighs 3915 kg and measures 2.80 x 1.46 x 1.90m.
