## VOLVO A40E

Year	2010
Hours	11630
Weight	30.200 kg
Serial number	VCE0A40EH00012865
Reference	208938

## INSPECTION REPORT

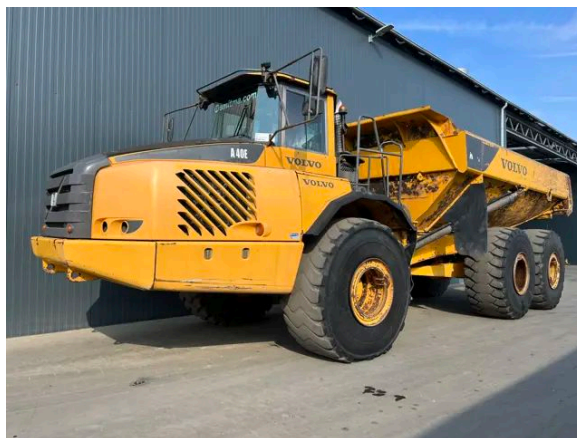
Volvo A40E, Engine Volvo , D16E, 346 kW, EPA, CE, Air conditioning, 6x6, Erops cabin, 29.5R25, Retarder, Backup camera, Backup alarm, Central lubrication, Beacon, AM/FM radio, In good and fairly clean condition.
