## INSPECTION REPORT

### CATERPILLAR 320E L

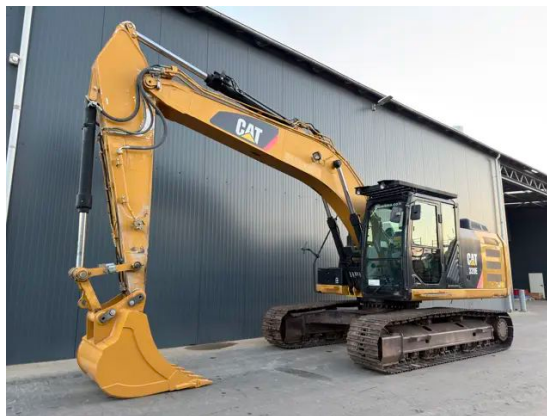
The Caterpillar 320E L is a robust excavator ideal for various heavy-duty applications. With a Caterpillar C6.6 engine providing 113 kW of power, this machine ensures efficient operation. It features a mono boom of 5.70m and a stick of 2.90m, paired with a new 1.20m digging bucket equipped with teeth. Additional features include air conditioning, an AM/FM radio, EPA and CE certifications, and a backup camera for enhanced safety. This excavator is piped for a hammer and includes a burst valve on the lift and stick cylinder, adding to its versatility. Certified hours by Caterpillar affirm its maintained condition, making it a reliable choice for construction projects.
