INSPECTION REPORT

CATERPILLAR 320GC 07B

Year	2019
Hours	7320
Weight	21.100 kg
Serial number	CAT00320HKTN10339
Reference	212037

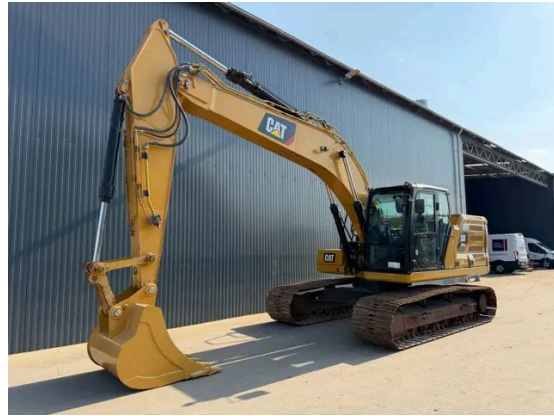
The Caterpillar 320GC 07B is a robust excavator ideal for heavy-duty operations. It's equipped with a powerful Caterpillar C4.4 engine delivering 91kW, meeting emission standards with Stage IV compliance. It features a spacious, air-conditioned cabin, backup camera, and extensive hydraulic capabilities, including piping for both hammer and shear. The machine is designed with a mono boom and a new digging bucket with teeth, ensuring efficient digging and lifting. With a clean and well-maintained condition, this 2019 model promises reliability and efficiency for any construction project.
