CATERPILLAR 330D L

Year	2008
Hours	10480
Weight	35300 kg
Serial number	CAT0330DEMWP03302
Reference	208167

INSPECTION REPORT

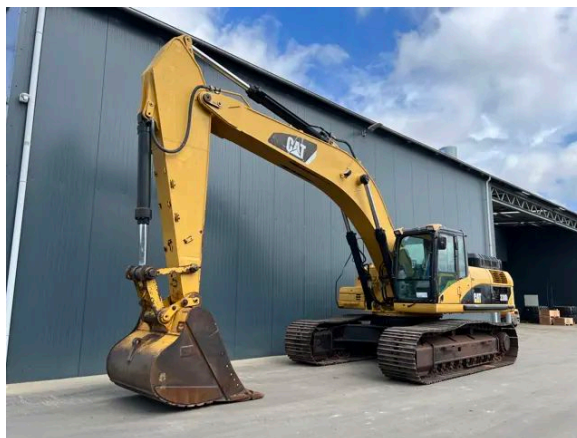
Caterpillar 330DL, Engine brand and model Caterpillar C9, Air conditioning, Width of the pads 800mm, Mono boom, Length of the mono boom 6.50m, Length of the stick 3.20m, Digging bucket with teeth, Width of the bucket 1.52m, Hours certified by Caterpillar, In good and clean condition.
