## CATERPILLAR M318F

Year	2015
Hours	8019
Weight	17.700 kg
Serial number	CATM318FFE8B00646
Reference	210574

# INSPECTION REPORT

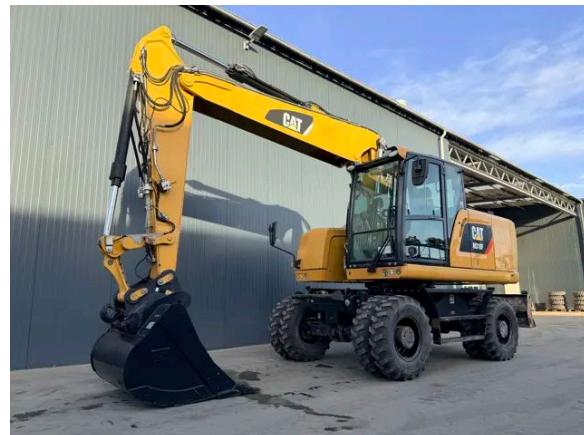
Caterpillar M318F, Engine brand Caterpillar, C7.1, 129 kW, Emission level IV, EPA, CE, Air conditioning, Central lubrication, Backup camera, Beacon, Tyre size 10.00-20, V/A boom, Length of the stick 2.40m, Piped for hammer, shear and clamp, Burst valve on lift, V/A and stick cylinder, AM/FM radio, Hours certified by Caterpillar, In very good and clean condition.
