## INSPECTION REPORT

### BOMAG BW161AD-5

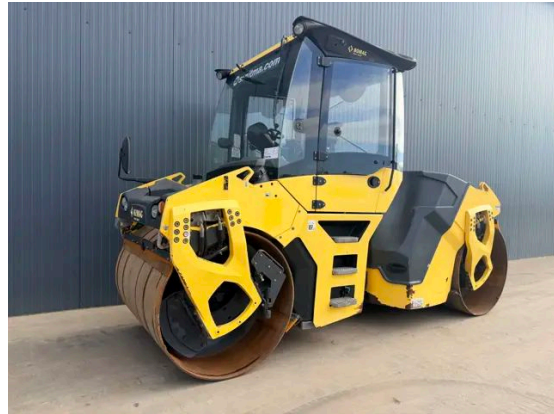
The Bomag BW 161AD-5 is a top-of-the-line vibrating roller in excellent and clean condition. Manufactured in 2016, it features a powerful Kubota V3800-T engine delivering 83.5kW. The machine is equipped with an EROPS cabin for operator comfort and safety, water sprinkler system, and drum drive with both drums vibrating. The 1.66m wide drum efficiently compacts surfaces, adhering to the Tier 4 emission standards with EPA and CE certifications. It includes a moveable seat, speed meter, cutting edge, and genuine hour meter, marking 4249 hours. The item's dimensions are 4.90m in length, 1.88m in width, and 3.05m in height, weighing 10370 kg.
