## INSPECTION REPORT

### CATERPILLAR 329E LN

Year	2014
Hours	12893
Weight	29.520 kg
Serial number	CAT0329EKRLD00475
Reference	211557

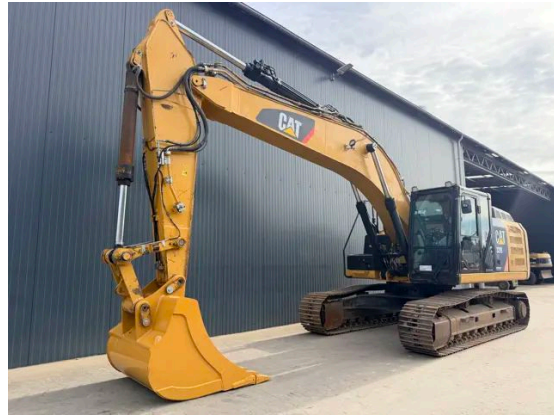
The Caterpillar 329E LN is a robust and efficient excavator perfect for a wide range of construction tasks. Equipped with a Caterpillar C7.1 engine delivering 180kW and meeting Stage 3B emission standards, this machine ensures sustainable performance. It features air conditioning, central lubrication, and a backup camera for enhanced comfort and safety. The mono boom is 6.15m long with a stick length of 2.65m, and it comes with a new 1.40m digging bucket, piped for hammer & shear. Its overall condition is excellent with hours certified by Caterpillar, backed by meticulous maintenance records.
