CATERPILLAR 320D L

Year	2008
Hours	14259
Weight	22.900 kg
Serial number	CAT0320DPKGF01214
Reference	210396

INSPECTION REPORT

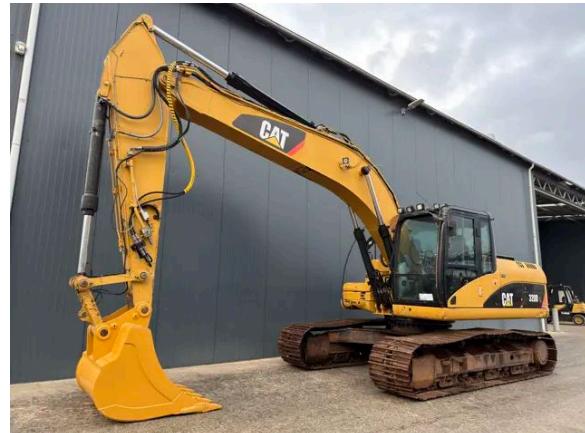
Caterpillar 320D L, Engine brand and model Caterpillar C6.4, 103 kW, CE, Central lubrication, Width of the pads 700mm, Mono boom, Length of the mono boom 5.70m, Length of the stick 2.90m, New digging bucket with teeth, Width of the bucket 1.23m, Piped for hammer, Burst valve on lift cylinder, Hours certified by Caterpillar, In good and clean condition.
