CATERPILLAR 318C L

Year	2004
Hours	10058
Weight	22.400 kg
Serial number	CAT0318CADAH00315
Reference	211095

INSPECTION REPORT

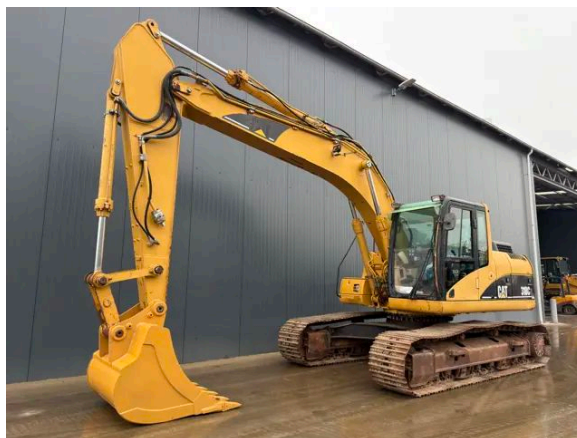
Caterpillar 318C L, Engine brand and model Caterpillar 3066T, Mechanical injection, 94 kW, EPA, CE, Width of the pads 600mm, Mono boom, Length of the mono boom 5.30m, Length of the stick 2.70m, New digging bucket with teeth, Width of the bucket 1.20m, Piped for hammer, Burst valve on lift cylinder, Hours certified by Caterpillar, In good and clean condition.
