## BOMAG BW135AD-5

Year	2016
Hours	2654
Weight	3.900 kg
Serial number	101650321317
Reference	208419

# INSPECTION REPORT

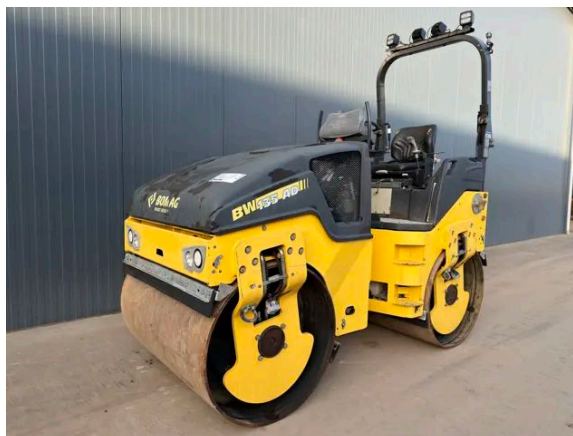
Bomag BW 135 AD-5, Kubota , V2203-M-ET05, 33.3 kW, Width of the drum 1.29m, EPA, CE, Erops cabin, Water sprinkler system, Drum drive, Both drum vibrating, Cutting edge, Moveable seat, Backup alarm, In very good and very clean condition.
