CATERPILLAR 323 07B | 70% GOOD U/C

INSPECTION REPORT

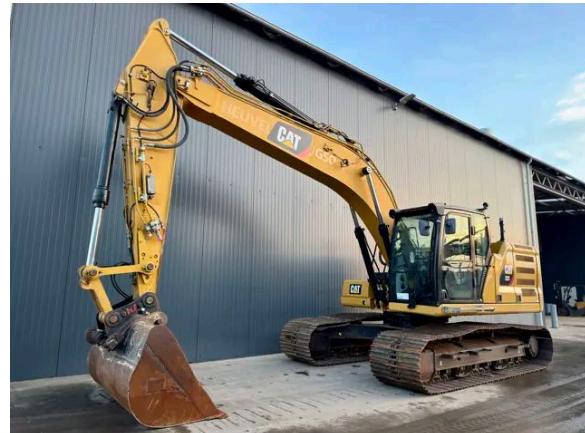
Caterpillar 323 07B, Engine brand and model Caterpillar C7.1, 122 kW, EPA, CE, Air conditioning, Central lubrication, Backup camera, Immobilizer, Cat walk, Integrated grade control, Width of the pads 900mm, Mono boom, Length of the mono boom 5.70m, Length of the stick 2.90m, Hydraulic quick release, Ditch cleaning bucket, Width of the bucket 2.10m, Piped for hammer, shear and clamp, Burst valve on lift and stick cylinder, Hours certified by Caterpillar, In very good and clean condition.
