INSPECTION REPORT

CATERPILLAR 140H II

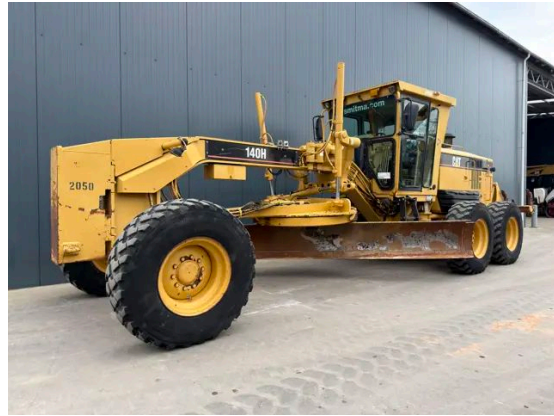
Introducing the Caterpillar 140H II Motor Grader, a robust and efficient machine powered by the Caterpillar 3176 engine, delivering a significant 138 kW. Manufactured in 2006, it features a low-profile EROPS cabin, hydraulic tip control, and a spacious 4.27m wide center blade. This machine is perfect for heavy-duty tasks with its 6x4 drivetrain, push block, and ripper attachments. The grader is in very good and clean condition, certified by Caterpillar, ensuring reliability for your operations. Additional extensions are available upon request.
