## INSPECTION REPORT

### WIRTGEN W210i

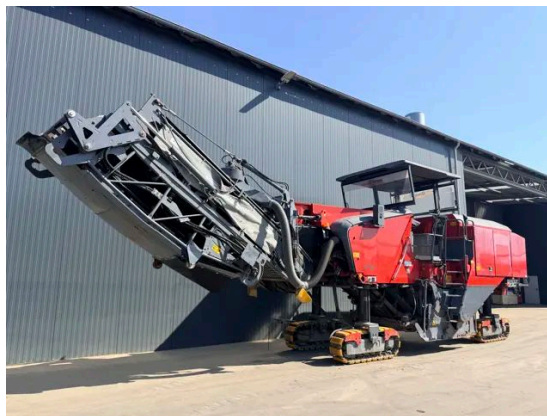
The Wirtgen W210i is a high-performance cold milling machine designed for demanding tasks. Equipped with powerful Cummins QSL9-380 & QSL9-300 engines generating 283 & 224 kW, it ensures efficient operation. The machine features a 2.00m wide milling drum, capable of a milling depth of 500mm. Its flexible cutter system and foldable conveyor belt make it versatile for various projects. Additional features include Wirtgen LEVEL PRO for precision, hydraulic systems for the conveyor and side plates, and a camera system for enhanced safety. This 2014 model has been maintained in very good condition, making it an excellent choice for high-demand milling tasks.
