## CATERPILLAR 325F LCR

Year	2018
Hours	11596
Weight	25.000 kg
Serial number	CAT0325FERBW20231
Reference	197517

## INSPECTION REPORT

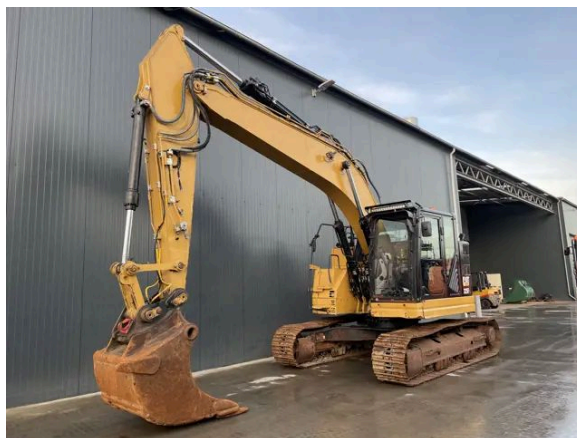
Caterpillar 325F LCR, Engine brand and model Caterpillar C4.4, 122kW, EPA, CE, Air conditioning, Central lubrication, Backup camera, Beacon, Width of the pads 600mm, Mono boom, Length of the mono boom 5.68m, Length of the stick 2.92m, Hydraulic quick release, Digging bucket with teeth, Width of the bucket 1.15m, Piped for hammer, shear and clamp, Burst valve on lift and stick cylinder, AM/FM Radio, Hours certified by Caterpillar, In very good and clean condition.
