## INSPECTION REPORT

### CATERPILLAR 330 07A

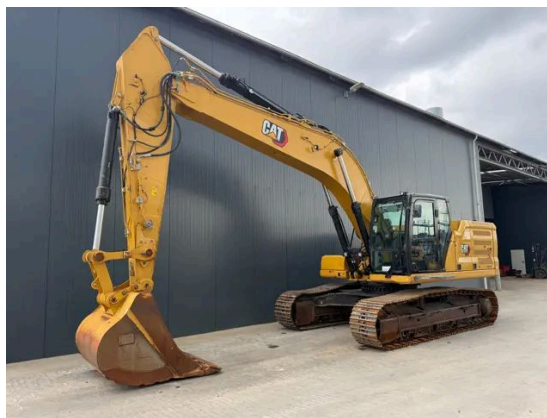
The Caterpillar 330 07A is a powerful and efficient excavator that combines advanced technology with rugged durability. It is equipped with a Caterpillar C7.1 engine producing 205kW and conforming to EPA and CE standards, meeting the Step 4 Final emission level. This machine offers features such as air conditioning, central lubrication, a backup camera, and an immobilizer for enhanced security and comfort. Its digging bucket features teeth and is piped for hammer use, ensuring versatile and productive operation. With a mono boom measuring 6.15 meters and a stick length of 3.20 meters, this excavator is well-suited for a variety of digging tasks. The Caterpillar 330 07A is in very good and clean condition, certified by Caterpillar, making it a reliable choice for demanding work environments.
