## INSPECTION REPORT

### CATERPILLAR 315 07B

Year	2022
Hours	4535
Weight	16000 kg
Serial number	CAT00315KWKX11657
Reference	211930

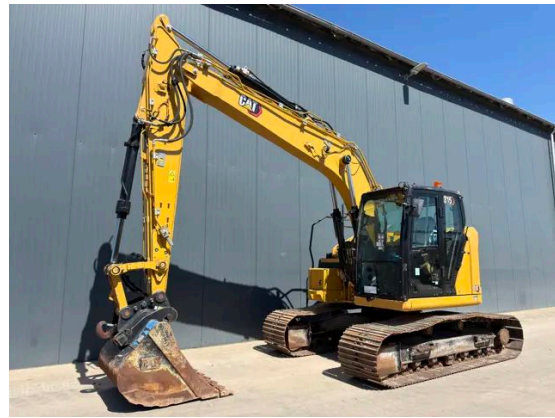
The Caterpillar 315 07B is a robust excavator equipped with the efficient Caterpillar C3.6 engine delivering 82 kW of power. This machine meets both EPA and CE standards and is packed with features such as air conditioning, a backup camera, and an immobilizer. It includes integrated grade control, a weight load indicator, and a mono boom system with a boom length of 4.65m and a stick length of 3.00m. The machine is also fitted with a hydraulic quick release, a 1.20m wide digging bucket with teeth, and is piped for a hammer. Additionally, the machine is in excellent condition with 4535 certified operational hours by Caterpillar.
