CATERPILLAR 314E LCR

INSPECTION REPORT

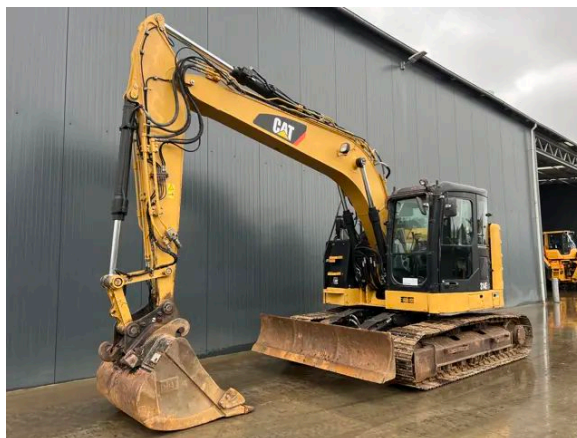
Caterpillar 314ELCR, Engine brand and model Caterpillar C4.4, 71 kW, EPA, Air conditioning, Central lubrication, Backup camera, Width of the pads 500mm, Mono boom, Length of the mono boom 4.65m, Length of the stick 2.50m, Hydraulic quick release, Digging bucket with teeth, Width of the bucket 1.21m, Piped for hammer, shear and clamp, Burst valve on lift and stick cylinder, Hours certified by Caterpillar, In very good and very clean condition.
