## CATERPILLAR 962H

# INSPECTION REPORT

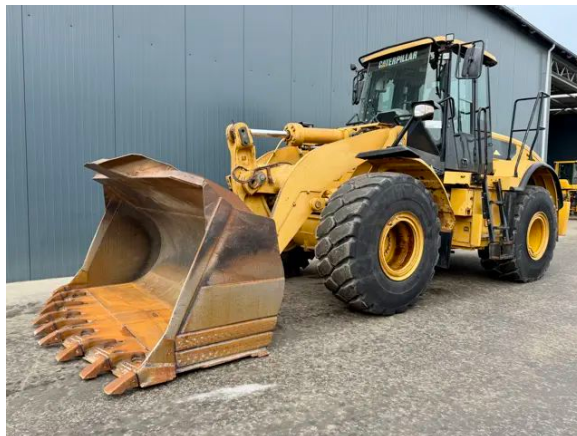
Caterpillar 962H, Engine and model Caterpillar C7, Air conditioning, Erops cabin, 23.5R25, GP bucket with teeth, Width of the bucket 2.95m, Complete steering wheel, Ride control, Autoshift, Backup camera, Cental lubrication available but not tested, Hours certified by Caterpillar, In good and very clean condition.
