CATERPILLAR 323DL VA

Year	2009
Hours	10478
Weight	24.050 kg
Serial number	CAT0323DJBYM00812
Reference	211967

INSPECTION REPORT

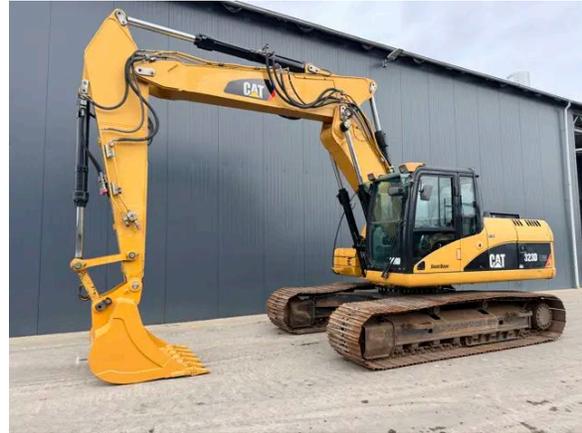
Caterpillar 323DL VA, Engine brand and model Caterpillar C6.4, 110kW, CE, Emission level Stage IIIA, Air conditioning, Backup camera, Width of the pads 800mm, V/A boom, Length of the stick 2,95m, New digging bucket with teeth, Width of the bucket 1,32m, Piped for hammer, shear and clamp, Burst valve on lift and V/A cylinder, AM/FM Radio, Hours certified by Caterpillar, In very good and clean condition.
