CATERPILLAR D8T - CE - NEW RIPPER

INSPECTION REPORT

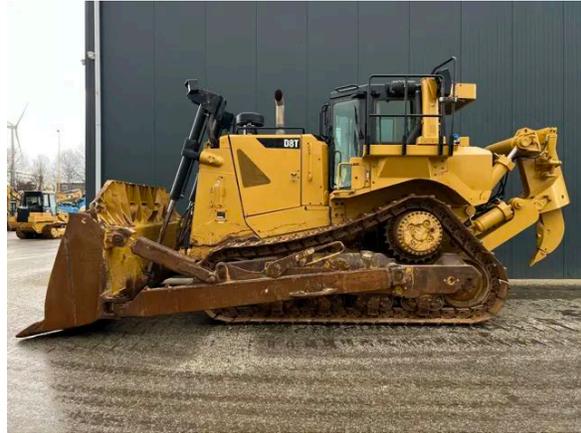
Caterpillar D8T, Engine brand Caterpillar , C15, 294 kW, CE, Air conditioning, Erops cabin, Straight tilt blade, Width of the blade 4.01m, Differential steering, Single shank ripper, Hydraulic pin puller, Width of the pads 610mm, Backup camera, AM/FM radio, Hours certified by Caterpillar, In very good and very clean condition.
