CATERPILLAR 950H

Year	2007
Hours	11151
Weight	18.500 kg
Serial number	CAT0950HLLN1A01430
Reference	210429

INSPECTION REPORT

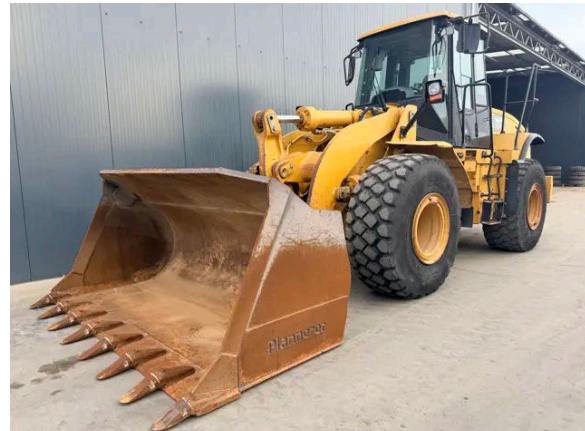
Caterpillar 950H, Engine and model Caterpillar C7DI, 146kW, CE, Emission level IIIA, Air conditioning, Erops cabin, 23,5 R25, GP bucket with teeth, Width of the bucket 2,98m, Command steer, Ride control, Autoshift, Backup alarm, Hours certified by Caterpillar, In very good and clean condition.
