BOMAG BW154AP-AM

Year	2008
Hours	4330
Weight	7300 kg
Serial number	101870601020
Reference	207372

INSPECTION REPORT

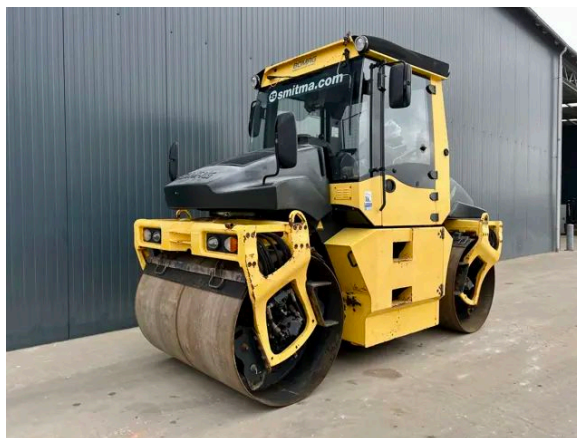
Bomag 154AP-AM, Kubota , V3307-DI-T-ET04, 55.4 kW, Width of the drum 1.50m, EPA, CE, Erops cabin, Water sprinkler system, Drum drive, Both drum vibrating, Compaction frequency variable controllable , Splitted drum, Cutting edge, Moveable seat, Compaction meter, Frequency meter, Speed meter, Air conditioning, Backup alarm, AM/FM radio, In very good and very clean condition.
