## INSPECTION REPORT

### DYNAPAC CC1200

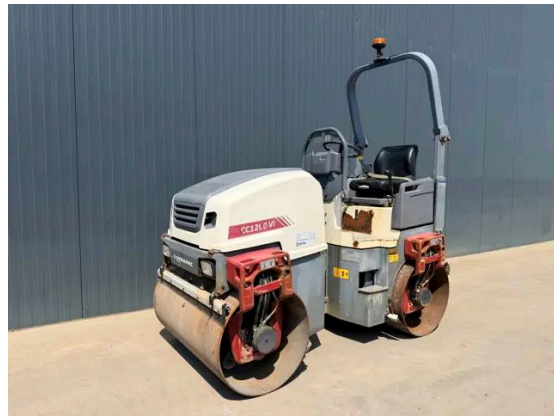
The Dynapac CC1200 is a versatile and efficient vibrating roller ideal for small to medium-sized construction projects. Equipped with a Kubota D1703 engine producing 26 kW, it offers robust performance and meets Tier 4 emission standards. The drum width is 1.20 meters, and it features a water sprinkler system, drum drive, and both drum vibrating mechanisms. This model ensures safety with a backup alarm and beacon. With genuine 2070 hours and in very good and clean condition, it's a reliable choice for your operations.
