CATERPILLAR 336F L

Year	2017
Hours	8173
Weight	37.780 kg
Serial number	CAT0336FLKCS10031
Reference	211671

INSPECTION REPORT

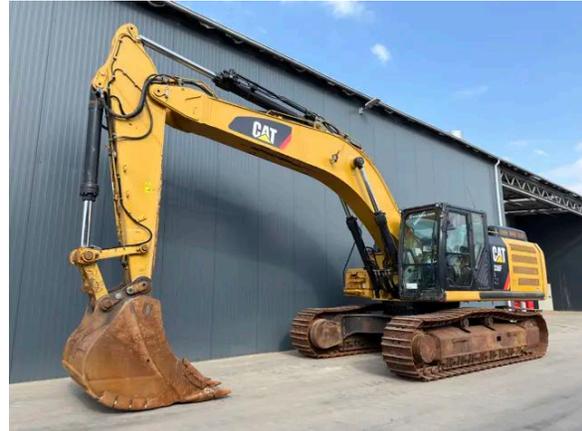
Caterpillar 336FL , Engine brand and model Caterpillar , 236 kW, EPA, CE, Air conditioning, Central lubrication, Backup camera, Width of the pads 600mm, Mono boom, Length of the mono boom 6.50m, Length of the stick 2.80m, Digging bucket with teeth, Width of the bucket 1.57m, Burst valve on lift and stick cylinder, AM/FM Radio, Hours certified by Caterpillar, In very good and clean condition.
