CATERPILLAR 320FL VA

INSPECTION REPORT

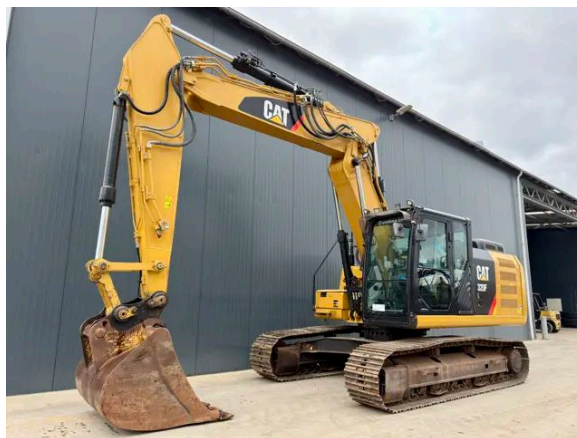
Caterpillar 320FL VA, Engine brand and model Caterpillar C4.4, 122 kW, EPA, CE, Air conditioning, Backup camera, Width of the pads 600mm, V/A boom, Length of the stick 2.90m, Hydraulic quick release, Digging bucket with teeth, Width of the bucket 1.34m, Piped for hammer & shear, Burst valve on lift, V/A and stick cylinder, AM/FM Radio, Hours certified by Caterpillar, In good and very clean condition.
