CATERPILLAR 740

Year	2007
Hours	14677
Weight	32.840 kg
Serial number	CAT00740HB1P02621
Reference	208062

INSPECTION REPORT

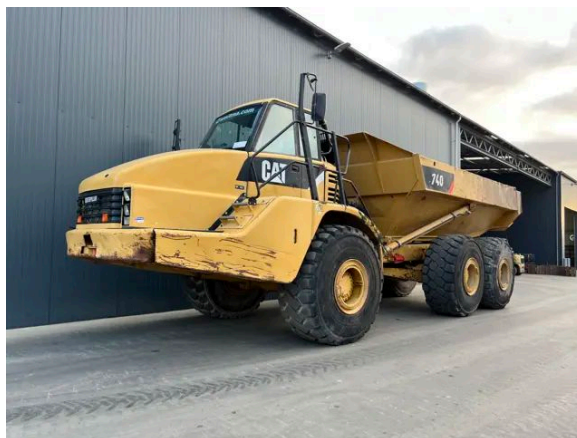
Caterpillar 740, Engine Caterpillar , C15, 327 kW, CE, Air conditioning, 6x6, Erops cabin, 29.5R25, Retarder, Backup alarm, Central lubrication, Fast fuel system, Hours certified by Caterpillar, In good and clean condition.
