## INSPECTION REPORT

### DYNAPAC CC1300

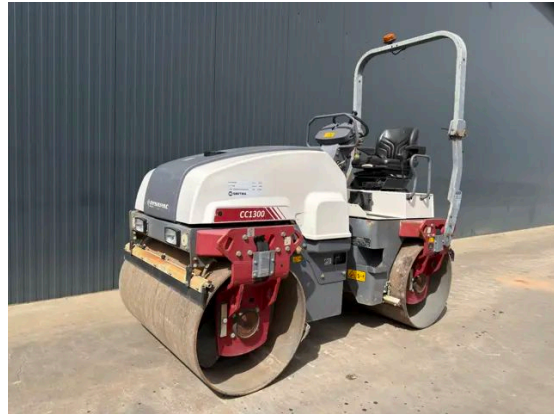
The Dynapac CC1300 is a high-quality vibrating roller designed for optimal performance. Powered by a Kubota V2203-M-ET05 engine with 33.3 kW, this machine offers reliable power and efficiency. It features a 1.30m drum width and includes an EROPS cabin, water sprinkler system, drum drive, and both drums vibrating for superior compaction. This unit also comes with safety features like a backup alarm and beacon, and is in very good and clean condition. Manufactured in 2019, it has minimal operation with 1080 running hours, making it a great investment for construction businesses.
