CATERPILLAR D9T

Year	2017
Hours	0
Weight	0
Serial number	CAT00D9TETWG00794
Reference	210147

INSPECTION REPORT

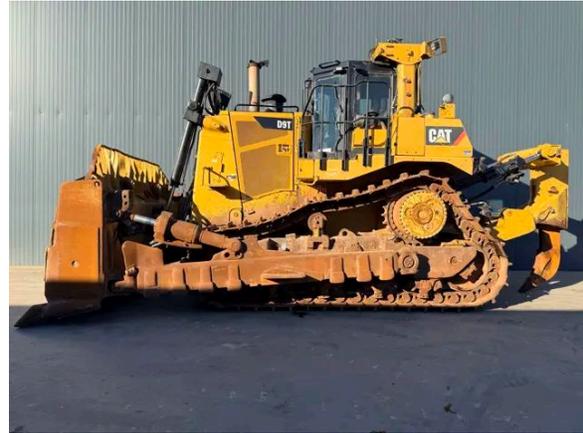
Caterpillar D9T, Engine brand Caterpillar, C18, 375kW, Air conditioning, Erops cabin, Straight tilt blade, Width of the blade 4,10m, Differential steering, Single shank ripper, Width of the pads 610mm, AM/FM radio, Hours certified by Caterpillar, In very good and clean condition.
