INSPECTION REPORT

VOLVO EW180D

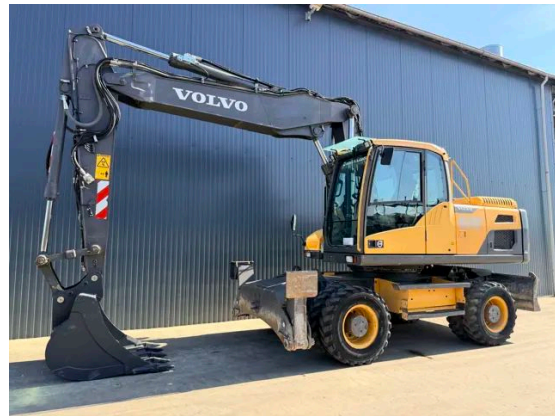
The Volvo EW180D is a robust wheeled excavator, powered by a reliable Volvo D6H engine with a power output of 129kW. Manufactured in 2014, this machine has genuine operating hours of 7801, and is in good, very clean condition. Equipped with air conditioning, central lubrication, a backup camera, and a V/A boom. It comes with a new digging bucket with teeth, a piped setup for hammer and shear, and a burst valve on the lift and V/A cylinder. The tyre size is 11.00-20, and the machine weighs 20,500 kg. The EW180D offers a spacious cabin with AM/FM radio for a pleasant work environment.
