## INSPECTION REPORT

### CATERPILLAR 374D L

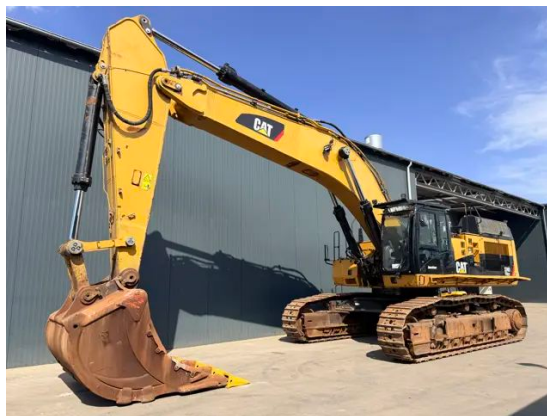
The Caterpillar 374D L is a high-performance excavator featuring a robust 382 kW Caterpillar C15 engine. This machine is equipped with advanced features including air conditioning, central lubrication, a backup camera, cabin protection, and a catwalk. It has a mono boom with a length of 7.80 meters and a 3.60-meter stick. The digging bucket is fitted with teeth and measures 2.10 meters in width. This excavator is piped for a hammer and comes with a retractable undercarriage and an AM/FM radio. Hours are certified by Caterpillar, indicating its reliable and clean condition.
