## INSPECTION REPORT

### CATERPILLAR 962M

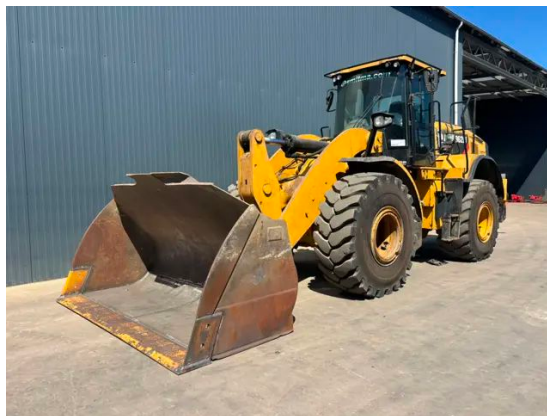
The Caterpillar 962M wheel loader boasts a powerful 200.9 kW engine meeting EPA Step 4 Final emissions standards. Equipped with air conditioning, an EROPS cabin, joystick steering, and a robust GP bucket with a width of 2.88m, the 962M offers comfort and productivity. With features such as ride control, autoshift, a backup camera, and a weight load indicator, this wheel loader is ready for any heavy-duty task. The machine is in exceptional condition with Caterpillar-certified hours.
