INSPECTION REPORT

CATERPILLAR 352F

Year	2017
Hours	12046
Weight	51700
Serial number	CAT0352FVND20140
Reference	212531

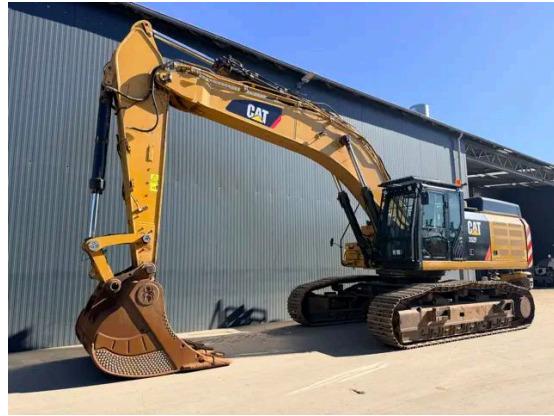
The Caterpillar 352F is a high-performance tracked excavator powered by a robust Caterpillar C13 engine delivering 317kW. It's equipped with essential systems such as EPA and CE certifications, air conditioning, and central lubrication for optimal operation. Additional features include a backup camera and alarm, cabin protection, and a beacon for enhanced safety. The machine is fitted with a 600mm-wide mono boom and a 3.30m stick, alongside a digging bucket with a width of 1.95m, making it ideal for demanding tasks. With 12046 certified hours by Caterpillar, this excavator maintains excellent performance and condition.
