## CATERPILLAR 140K

<b>Year</b>	2013
<b>Hours</b>	11777
<b>Weight</b>	15.000 kg
<b>Serial number</b>	CAT0140KCSZL02203
<b>Reference</b>	210141

# INSPECTION REPORT

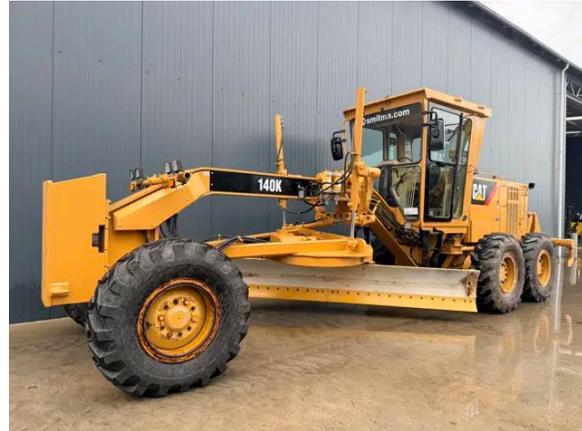
Caterpillar 140K , Engine and model Caterpillar C7, 143 kW, 14.00-24, Push block, Ripper, 6x4, High profile erops cabin, Auto shift, Hydraulic tip control, Blade lift accumulators, Differential unlock, Hours certified by Caterpillar, Beacon, Extensions available, ask for quotation, In good and clean condition.
