CATERPILLAR M316D

Year	2011
Hours	13899
Weight	17150
Serial number	CATM316DEW6A05419
Reference	211800

INSPECTION REPORT

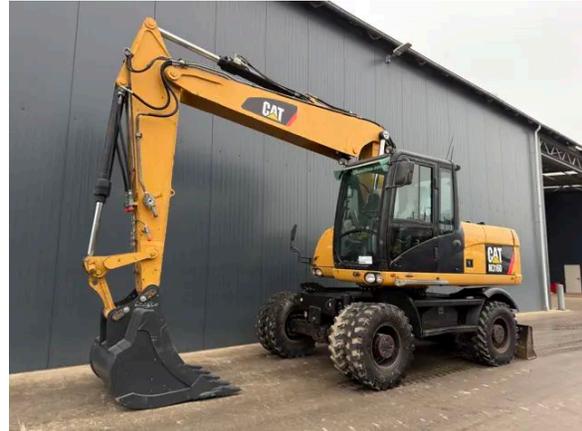
Caterpillar M316D, Engine brand Caterpillar, C6.6, 123 kW, CE, Backup camera, Cat walk, Tyre size 10.00-20, V/A boom, Length of the stick 2.60m, New digging bucket with teeth, Width of the bucket 1.20m, Piped for hammer & shear, Burst valve on lift, V/A and stick cylinder, Hours certified by Caterpillar, In good and very clean condition.
