INSPECTION REPORT

CATERPILLAR 140H II

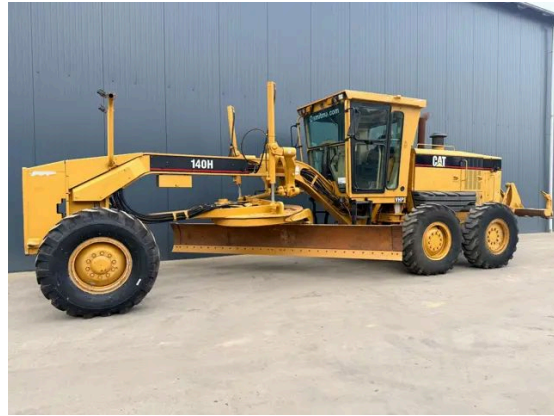
The Caterpillar 140H II Motor Grader is a robust and reliable piece of heavy machinery. Powered by a Caterpillar 3176c engine delivering 138kW, this machine is equipped with a differential lock/unlock system, air conditioning, and a low profile EROPS cabin designed for comfort and efficiency. The center blade, measuring 4.27 meters in width, ensures precise grading and leveling on various terrains. The machine is certified by Caterpillar for hours of operation, guaranteeing trust and dependability in performance. Additional attachments like extensions, a ripper, and a push block enhance its functionality. Manufactured in 2007 in Brazil, it remains in outstanding condition, certified as very good and clean, with maintenance records available.
