## INSPECTION REPORT

### HAMM HD+ 110i VO

Year	2017
Hours	2337
Weight	10090 kg
Serial number	H2420168
Reference	213270

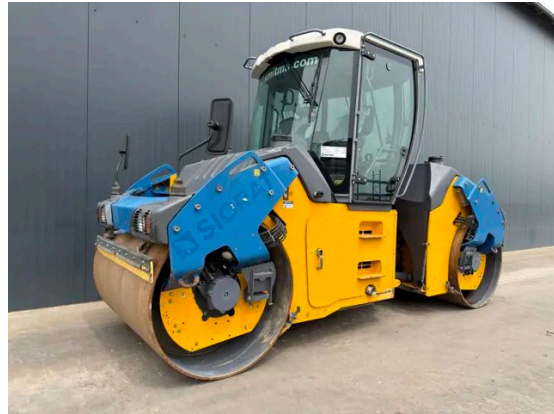
The HAMM HD+ 110i VO roller combines powerful performance with advanced features, making it suitable for a variety of construction projects. It is equipped with a Deutz TCD 3.6 L4 engine providing 85 kW of power. The machine's drum width is 1.68 meters and it features both EPA and CE certifications with an Erops cabin design for enhanced operator comfort. The roller includes a water sprinkler system, drum drive capability, and dual drum vibration with oscillation compaction that can be adjusted for frequency. A movable seat, frequency and speed meters, air conditioning, backup alarm, and beacon enhance safety and convenience. It is in excellent condition, with only 2337 run hours, offering reliability for heavy-duty tasks.
