## INSPECTION REPORT

### BOMAG BW161ADO-5

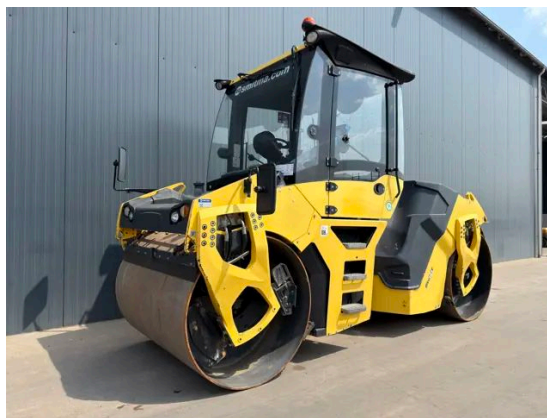
The Bomag BW161ADO-5 is a high-performance vibrating roller designed for heavy-duty compaction tasks. It is equipped with a Deutz TCD 3.6 L4 engine that generates 95 kW of power, and has a drum width of 1.68 meters. This machine complies with EPA and CE standards, features an enclosed EROPS cabin, and is fitted with a water sprinkler system. Its dual vibrating drum provides effective oscillation compaction. Additional features include a moveable seat, frequency meter, speed meter, air conditioning, backup alarm, and beacon. It is in excellent and clean condition.
